The Road Inventory of Pixley National Wildlife Refuge Tulare, CA

Prepared By: Federal Highway Administration Central Federal Lands Highway Division March 2012

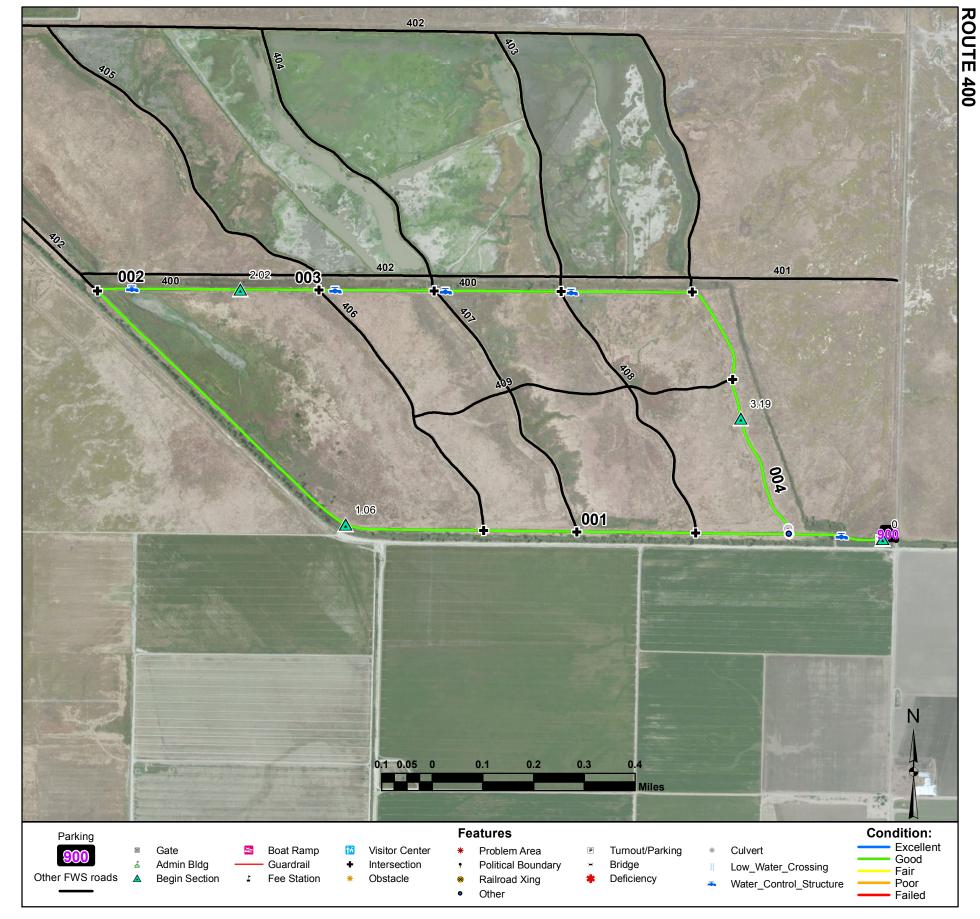
Wetland Units 6,7,8,9 Boundary Road

Asset Number	-	-	-	-	
Section Number	001	002	003	004	
Section Length (miles)	1.06	0.96	1.17	0.25	
Inspection Date	12-14-2011	12-14-2011	12-14-2011	12-14-2011	
Surface Type	Gravel	Gravel	Gravel	Gravel	
Number of Lanes	1	1	1	1	
Roadway Width (feet)	12	12	12	12	
Condition	Good	Good	Good	Good	
Remaining Service Life (years)	5	5	5	7	
Estimated Cost to Repair	\$2,100	\$1,900	\$2,300	\$500	
Current Replacement Value	\$879,500	\$792,900	\$970,400	\$208,500

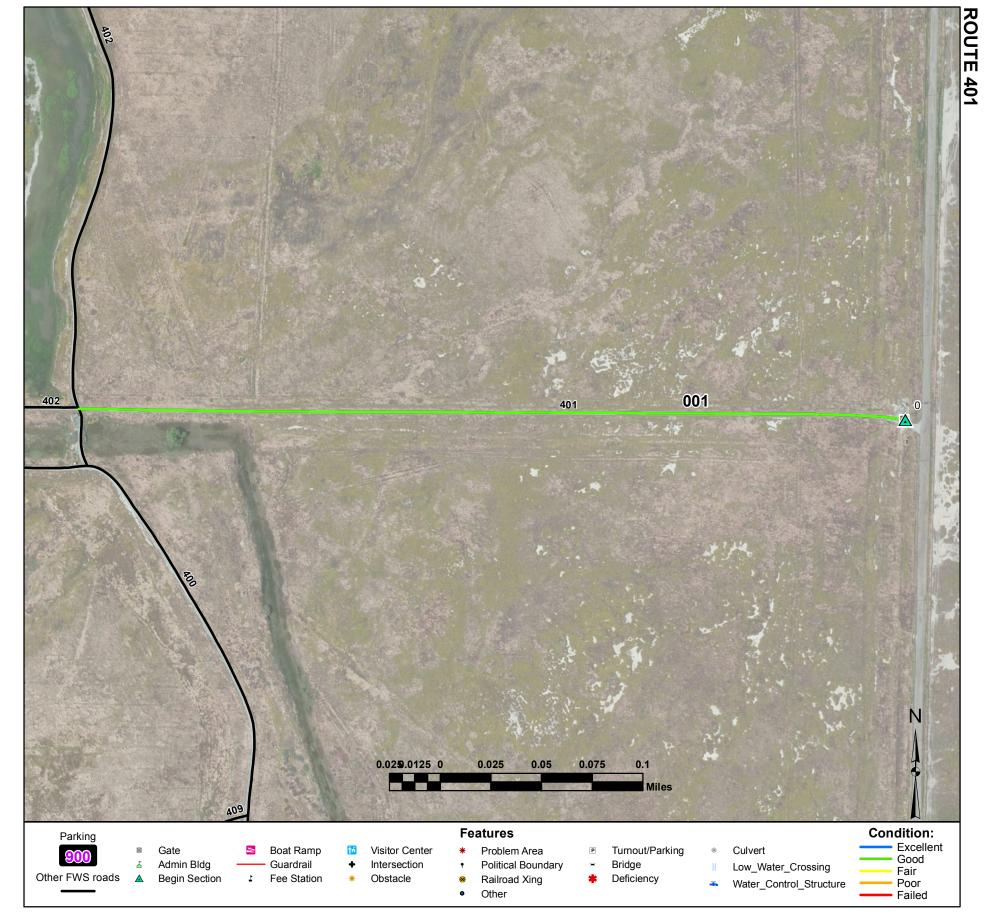
East Side Groundwater Well Road

Asset Number	-
Section Number	001
Section Length (miles)	0.41
Inspection Date	12-14-2011
Surface Type	Gravel
Number of Lanes	1
Roadway Width (feet)	12
Condition	Good
Remaining Service Life (years)	7
Estimated Cost to Repair	\$800
Current Replacement Value	\$337,800

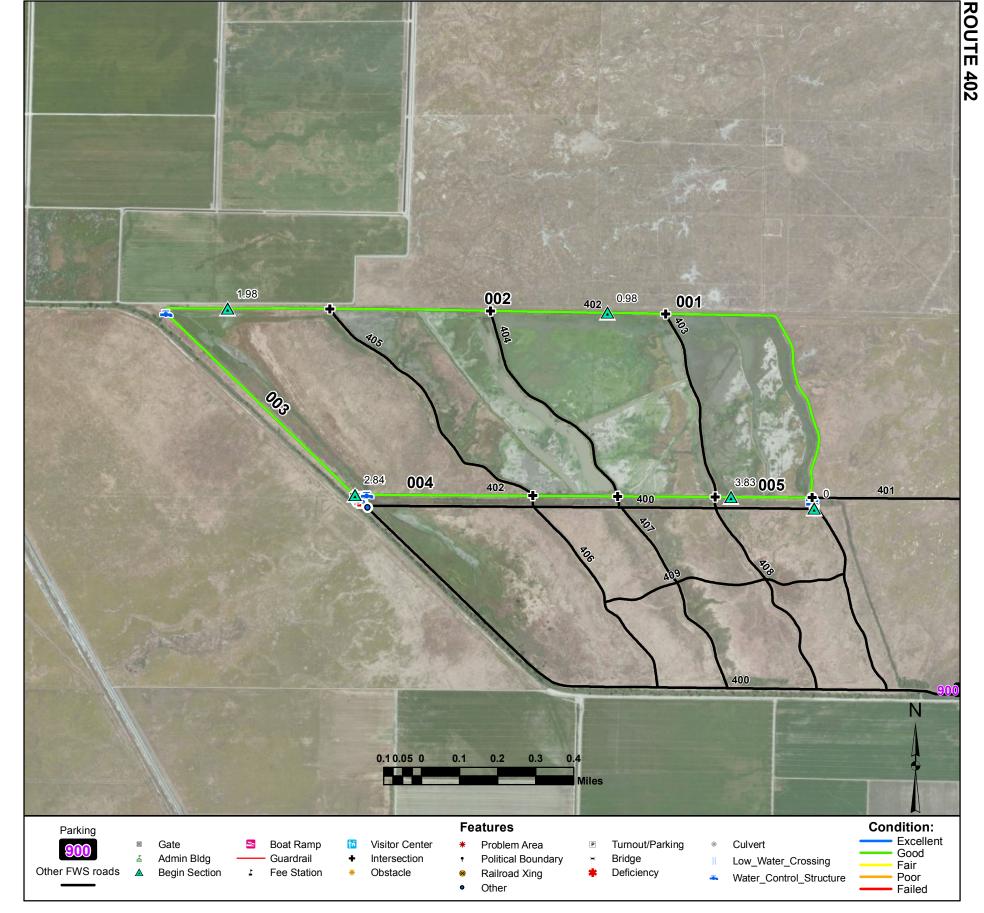
Wetland Units 1, 2, 3, 4 Boundary Road

Asset Number	-	-	-	-	-
Section Number	001	002	003	004	005
Section Length (miles)	0.98	1.00	0.91	0.99	0.21
Inspection Date	12-14-2011	12-14-2011	12-14-2011	12-14-2011	12-14-2011
Surface Type	Gravel	Gravel	Gravel	Gravel	Gravel
Number of Lanes	1	1	1	1	1
Roadway Width (feet)	12	12	12	12	12
Condition	Good	Good	Good	Good	Good
Remaining Service Life (years)	7	5	5	7	7
Estimated Cost to Repair	\$1,900	\$1,900	\$1,800	\$1,900	\$400
Current Replacement Value	\$809,200	\$828,100	\$755,100	\$820,000	\$177,100

Features	Mile Post	Features	Mile Post	Features	Mile Post	Features	Mile Post
Begin Section Other Water Control Structure	001-0.0 001-0.0 001-0.01	Begin Section Other Water Control Structure	004-2.84 004-2.84 004-2.87				
Intersection Water Control Structure Intersection Begin Section	001-0.03 001-0.03 001-0.81 002-0.98	Intersection Intersection Intersection Begin Section	004-3.31 004-3.53 004-3.79 005-3.83				
Intersection Intersection Begin Section	002-1.28 002-1.71 003-1.98	Other	005-4.04				
Water Control Structure Intersection DeficiencyCulvert Water Control Structure	003-2.16 003-2.84 003-2.86 003-2.86						
Other	003-2.89

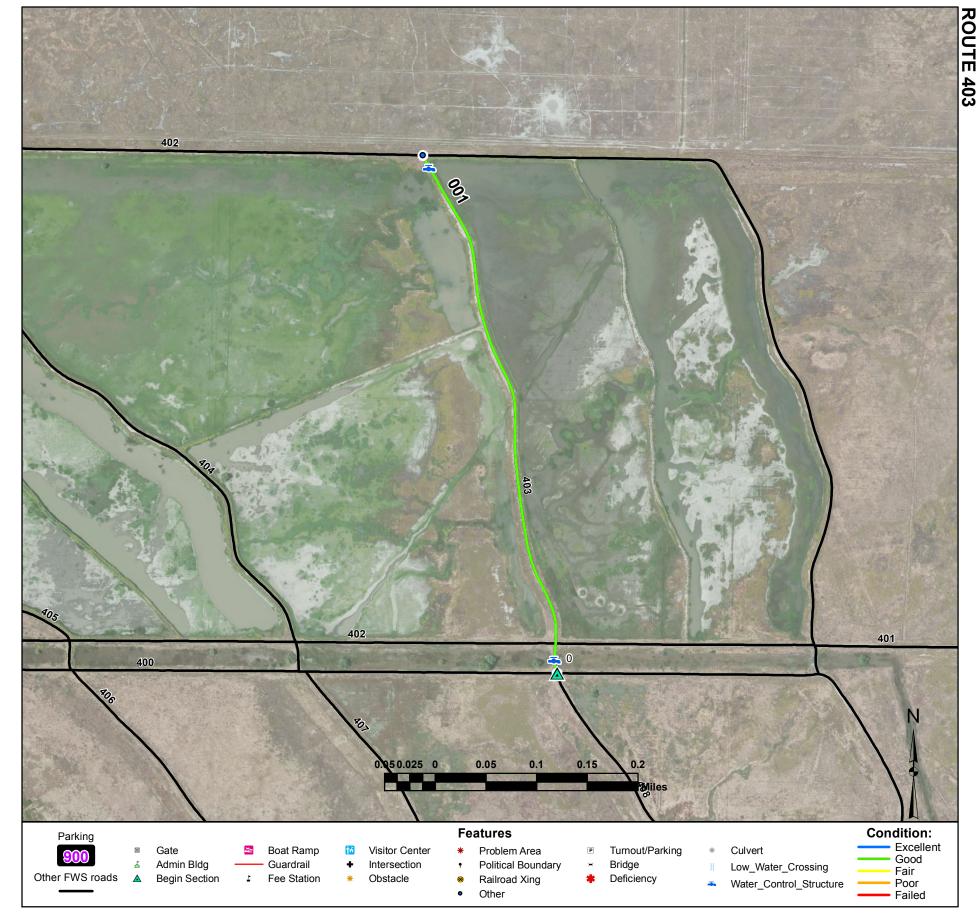
Wetland Units 3, 3A, 4 Cross Dike Road
From Wetland Units 6,7,8,9 Boundary Road (Route 400) to Wetland Units 1, 2, 3, 4 Boundary Road (Route 402)

Ü
Asset Number	-		
Section Number	001		
Section Length (miles)	0.54		
Inspection Date	12-14-2011		
Surface Type	Gravel		
Number of Lanes	1		
Roadway Width (feet)	12		
Condition	Good		
Remaining Service Life (years)	7		
Estimated Cost to Repair	\$1,000		
Current Replacement Value	\$444,500

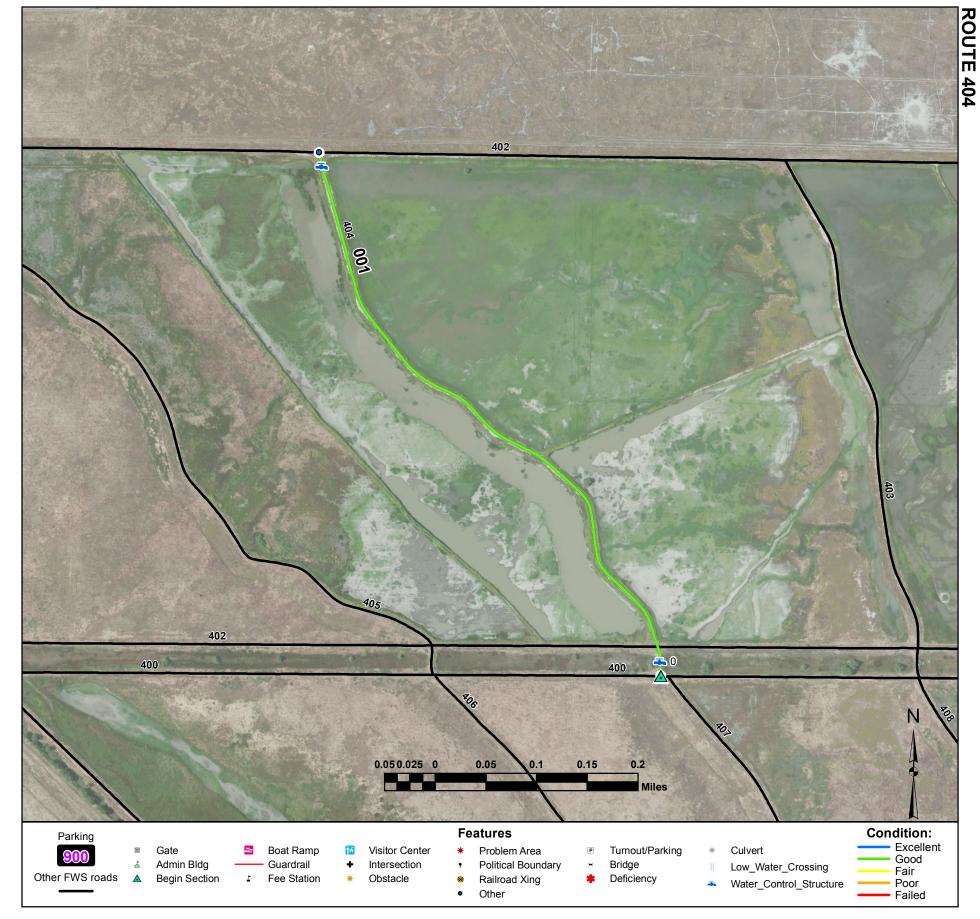
Wetland Units 2, 3, 3A Cross Dike Road
From Wetland Units 6,7,8,9 Boundary Road (Route 400) to Wetland Units 1, 2, 3, 4 Boundary Road (Route 402)

Asset Number	-
Section Number	001
Section Length (miles)	0.65
Inspection Date	12-14-2011
Surface Type	Gravel
Number of Lanes	1
Roadway Width (feet)	12
Condition	Good
Remaining Service Life (years)	5
Estimated Cost to Repair	\$1,300
Current Replacement Value	\$538,900

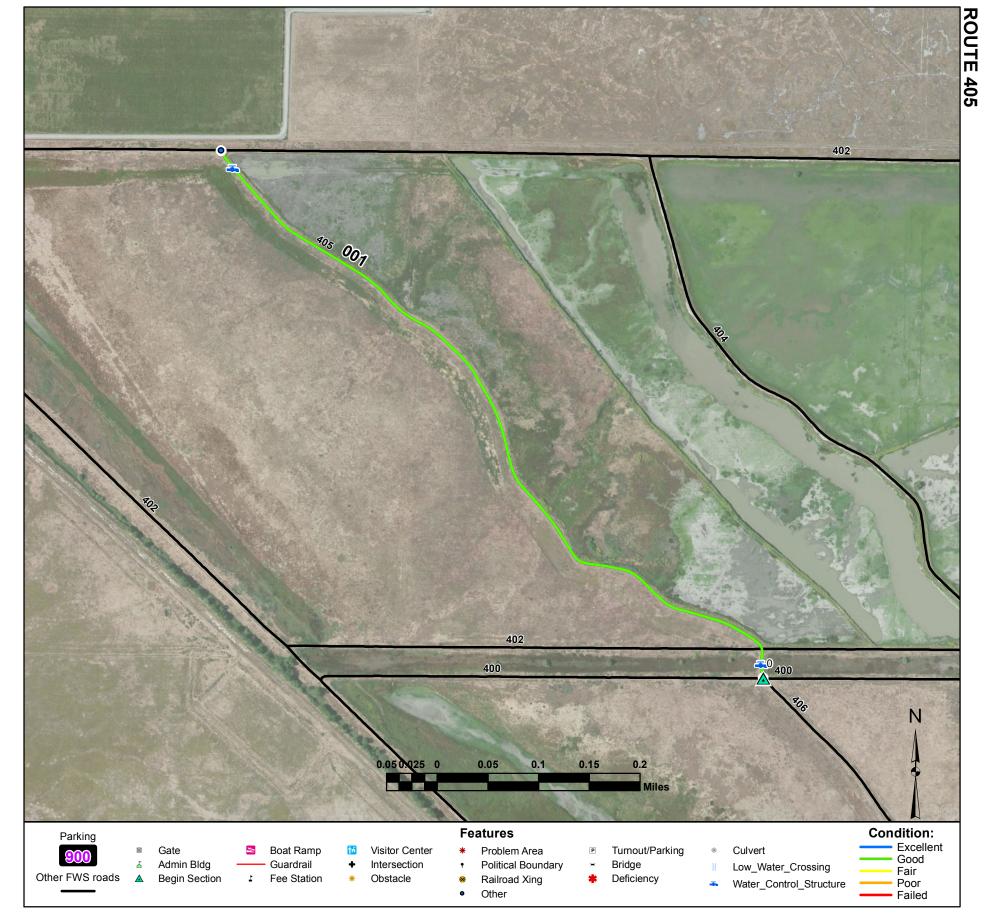
Wetland Units 1, 2A Cross Dike Road

Asset Number	-		
Section Number	001		
Section Length (miles)	0.79		
Inspection Date	12-14-2011		
Surface Type	Gravel		
Number of Lanes	1		
Roadway Width (feet)	12		
Condition	Good		
Remaining Service Life (years)	5		
Estimated Cost to Repair	\$1,500		
Current Replacement Value	\$651,600

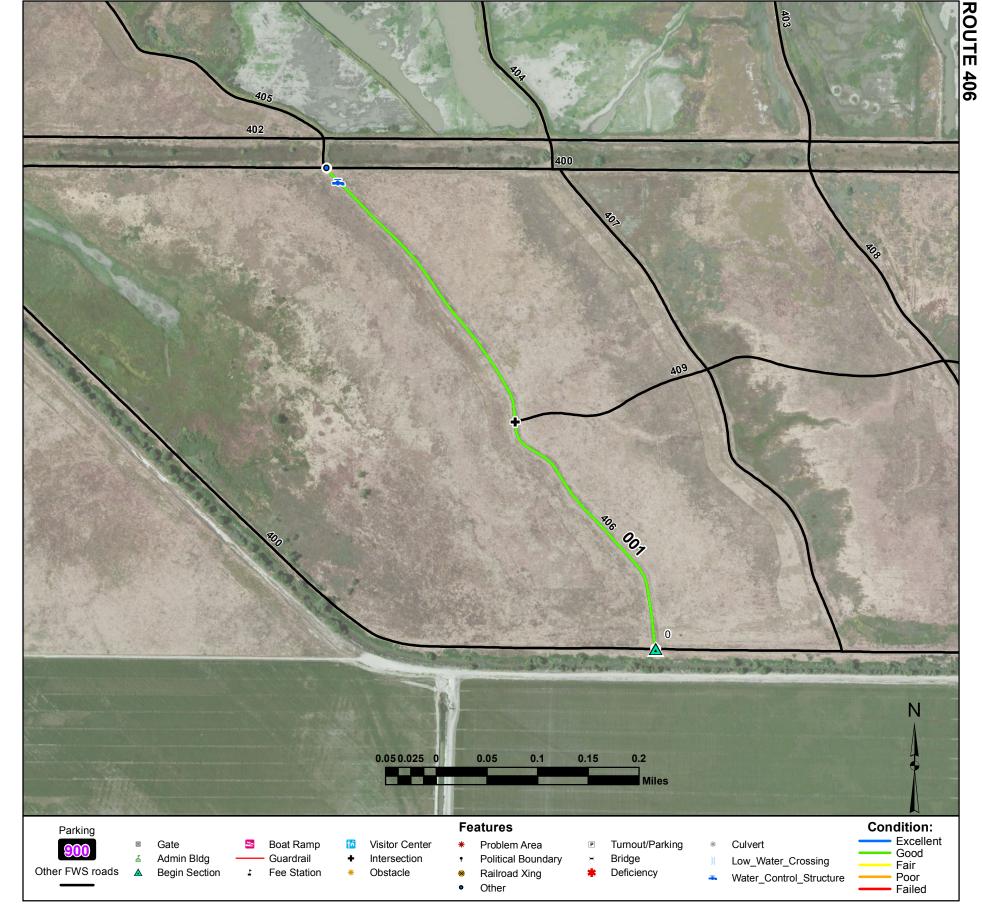
Wetland Units 6, 7 Cross Dike Road

Asset Number	-		
Section Number	001		
Section Length (miles)	0.59		
Inspection Date	12-14-2011		
Surface Type	Gravel		
Number of Lanes	1		
Roadway Width (feet)	12		
ondition	Good		
emaining Service Life (years)	7		
stimated Cost to Repair	\$1,200		
Current Replacement Value	\$490,400

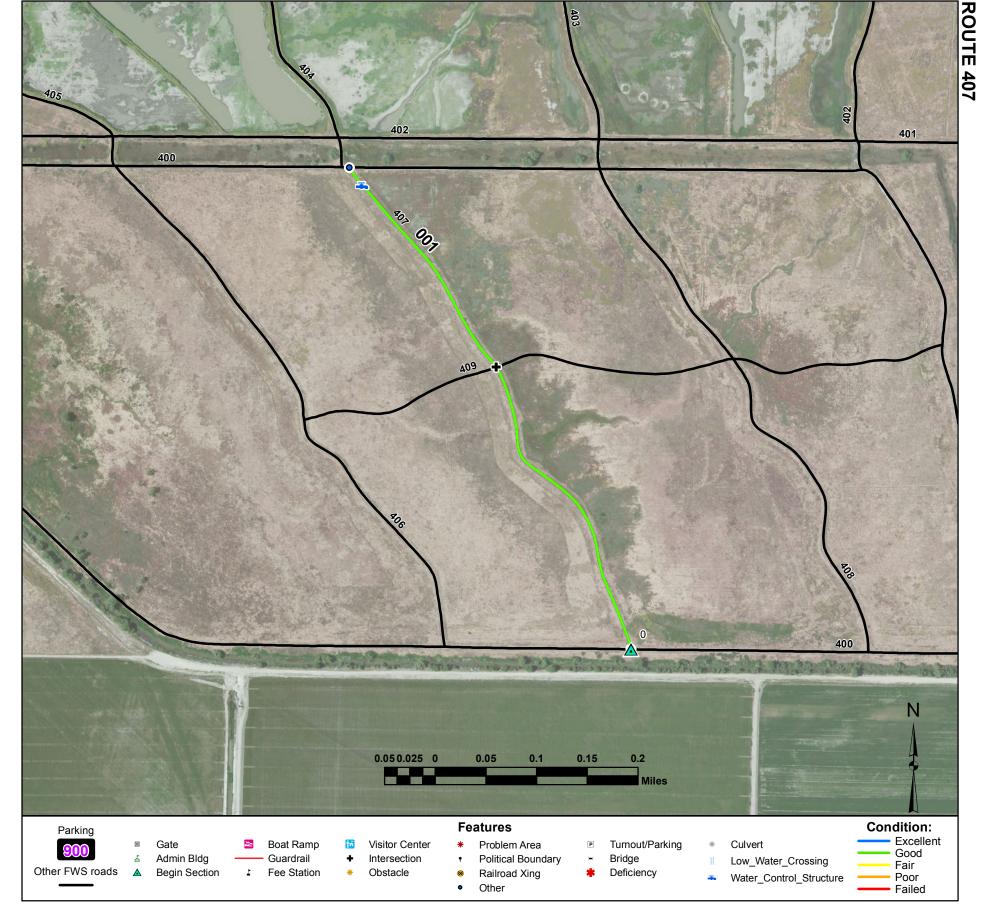
Wetland Units 7, 8 Cross Dike Road
From Wetland Units 6,7,8,9 Boundary Road (Route 400) to Wetland Units 6,7,8,9 Boundary Road (Route 400)

Asset Number	-		
Section Number	001		
Section Length (miles)	0.56		
Inspection Date	12-14-2011		
Surface Type	Gravel		
Number of Lanes	1		
Roadway Width (feet)	12		
Condition	Good		
Remaining Service Life (years)	5		
Estimated Cost to Repair	\$1,100		
Current Replacement Value	\$467,800

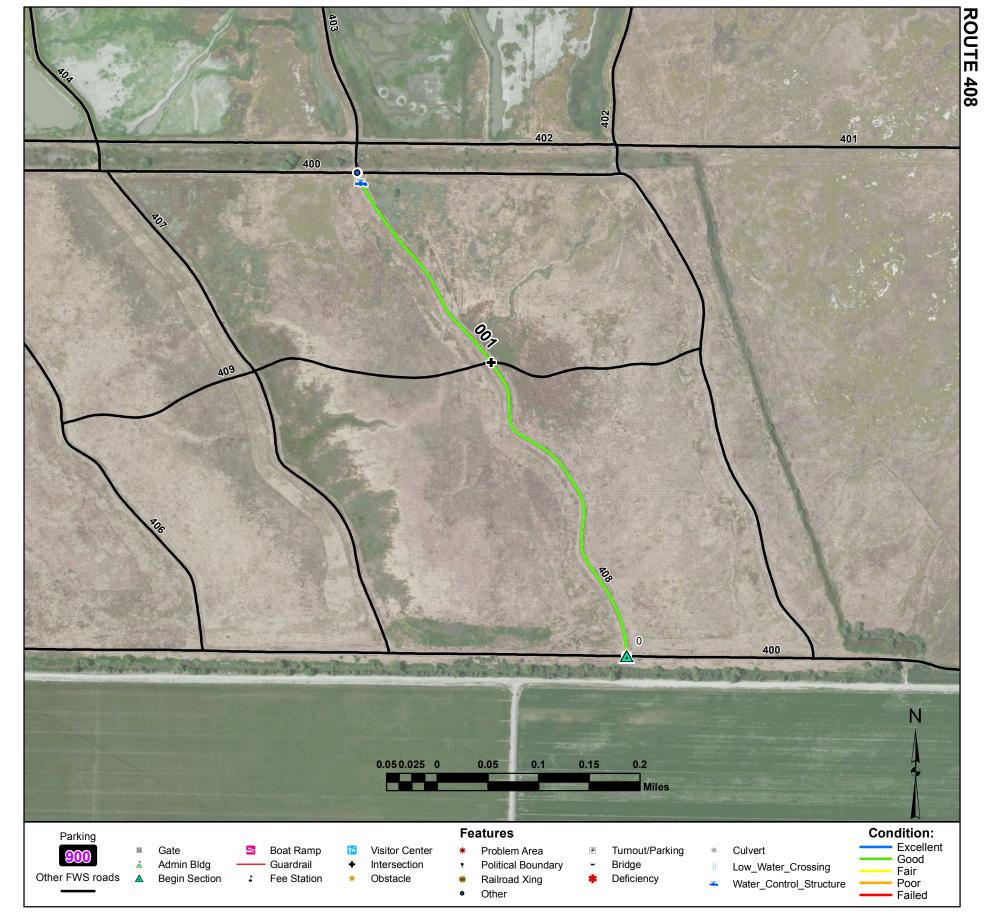
Wetland Units 8, 9 Cross Dike Road

Asset Number	-
Section Number	001
Section Length (miles)	0.57
Inspection Date	12-14-2011
Surface Type	Gravel
Number of Lanes	1
Roadway Width (feet)	12
Condition	Good
Remaining Service Life (years)	7
Estimated Cost to Repair	\$1,100
Current Replacement Value	\$469,400

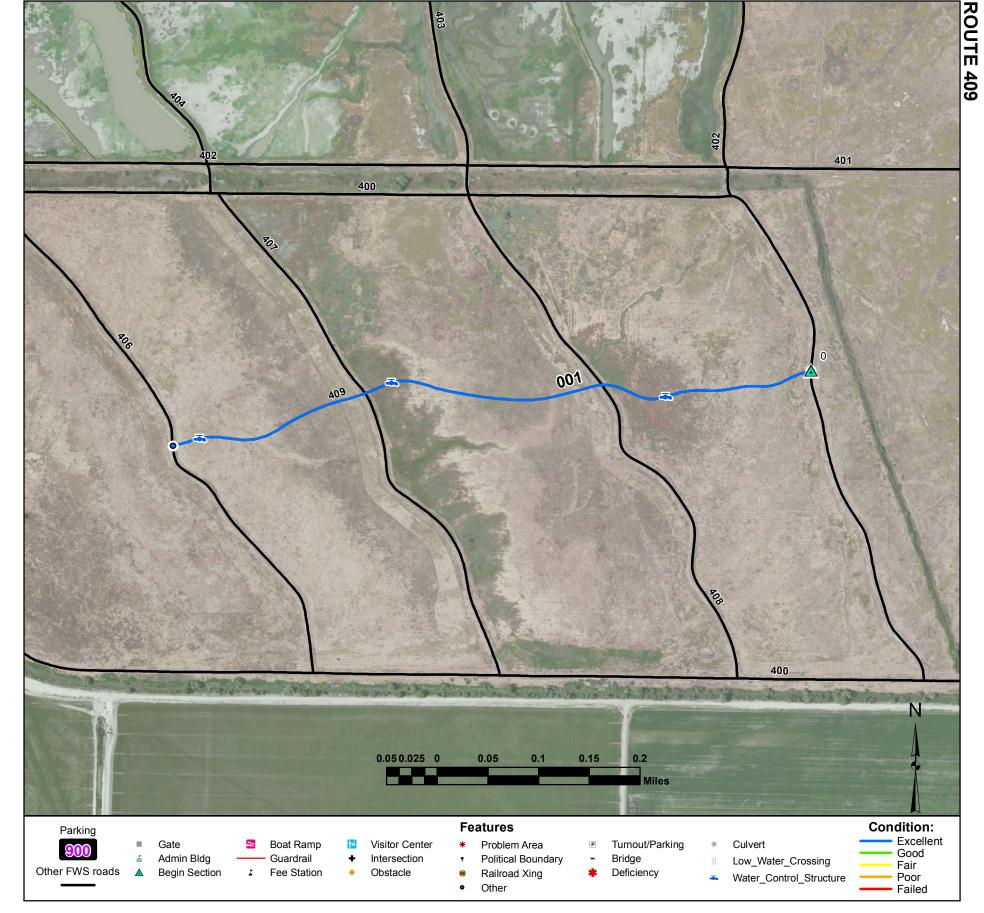
Wetland Units 7, 8, 9 Center Levee Road From Wetland Units 6,7,8,9 Boundary Road (Route 400) to Wetland Units 6, 7 Cross Dike Road (Route 406)

Asset Number	-		
Section Number	001		
Section Length (miles)	0.65		
nspection Date	12-14-2011		
_			
urface Type	Native		
Number of Lanes	1		
Roadway Width (feet)	12		
ndition	Excellent		
emaining Service Life (years)	8		
stimated Cost to Repair	\$0		
Current Replacement Value	\$280,000

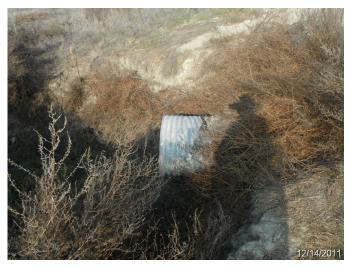
Photo: PIXL_C4_0504 Route: 402-003-2.16 Metal WCS Flashboard Riser 40ft long 36in dia. 5ft deep Asset# NA

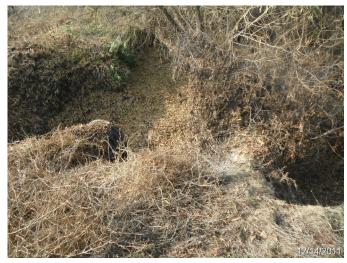
Photo: PIXL_C4_0505 Route: 402-003-2.86 Plastic WCS Flashboard Riser 70ft long 48in dia. 5ft deep Asset# NA

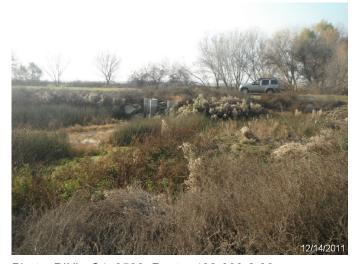
Photo: PIXL_C4_0506 Route: 402-003-2.86 Plastic WCS Flashboard Riser 70ft long 48in dia. 5ft deep Asset# NA 8-006

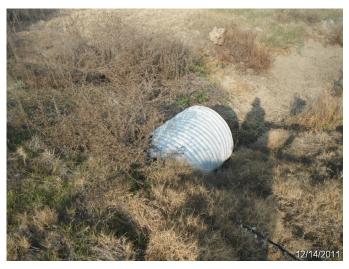
Photo: PIXL_C4_0509 Route: 402-004-2.87 Metal WCS Flashboard Riser 40ft long 36in dia. 3ft deep Asset# NA

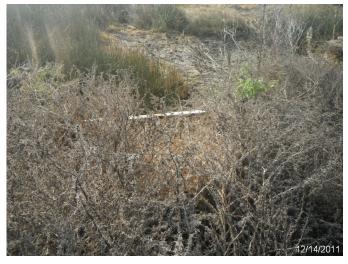
Photo: PIXL_C4_0510 Route: 402-004-2.87 Metal WCS Flashboard Riser 40ft long 36in dia. 3ft deep Asset# NA

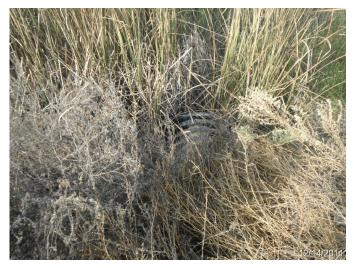
Photo: PIXL_C4_0515 Route: 403-001-0.01 Plastic WCS Flashboard Riser 40ft long 48in dia. 3ft deep Asset# NA

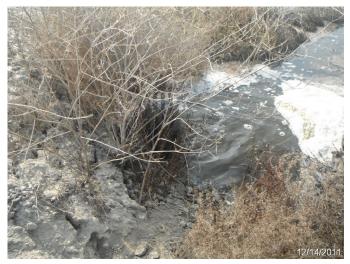
Photo: PIXL_C4_0517 Route: 403-001-0.52 Plastic WCS Flashboard Riser 25ft long 24in dia. 2ft deep Asset# NA

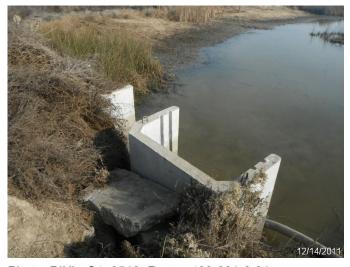
Photo: PIXL_C4_0513 Route: 403-001-0.01 Plastic WCS Flashboard Riser 40ft long 48in dia. 3ft deep Asset# NA

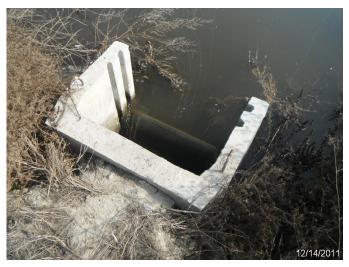
Photo: PIXL_C4_0516 Route: 403-001-0.52 Plastic WCS Flashboard Riser 25ft long 24in dia. 2ft deep Asset# NA

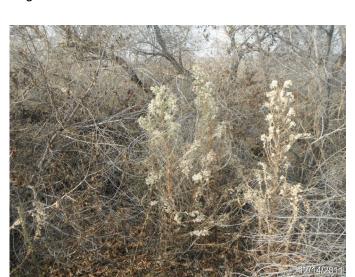
Photo: PIXL_C4_0521 Route: 404-001-0.01 Plastic WCS Flashboard Riser 50ft long 48in dia. 3ft deep Asset# NA

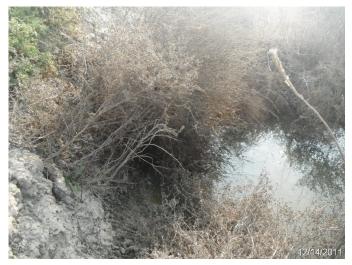
Photo: PIXL_C4_0519 Route: 404-001-0.64 Plastic WCS Flashboard Riser 25ft long 24in dia. 3ft deep Asset# NA

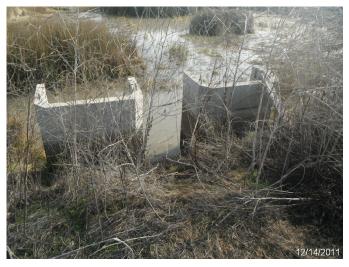
Photo: PIXL_C4_0520 Route: 404-001-0.01 Plastic WCS Flashboard Riser 50ft long 48in dia. 3ft deep Asset# NA

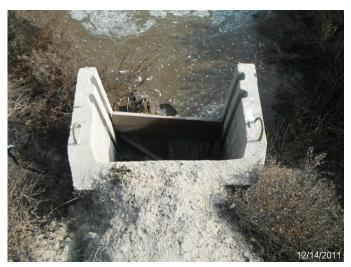
Photo: PIXL_C4_0518 Route: 404-001-0.64 Plastic WCS Flashboard Riser 25ft long 24in dia. 3ft deep Asset# NA

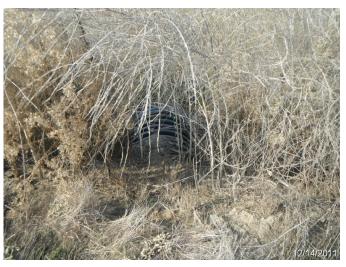
Photo: PIXL_C4_0525 Route: 405-001-0.01 Plastic WCS Flashboard Riser 40ft long 48in dia. 3ft deep Asset# NA

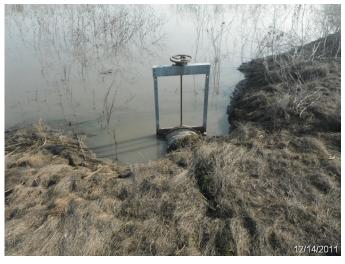
Photo: PIXL_C4_0526 Route: 405-001-0.77 Metal WCS Screw Gate 50ft long 24in dia. 2ft deep Asset# NA

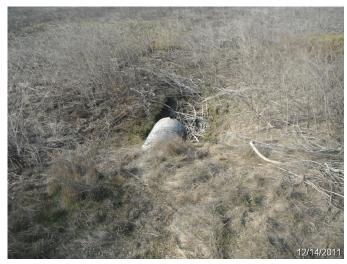
Photo: PIXL_C4_0527 Route: 405-001-0.77 Metal WCS Screw Gate 50ft long 24in dia. 2ft deep Asset# NA

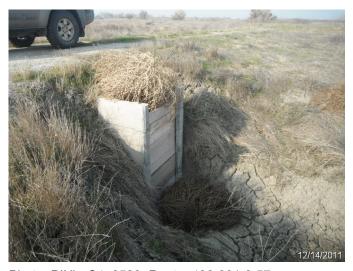
Photo: PIXL_C4_0528 Route: 406-001-0.57 Plastic WCS Flashboard Riser 50ft long 24in dia. 3ft deep Asset# NA

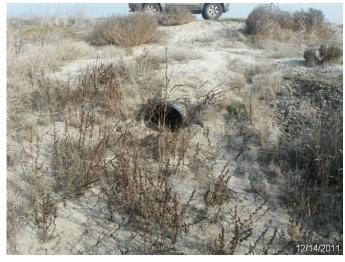
Photo: PIXL_C4_0529 Route: 406-001-0.57 Plastic WCS Flashboard Riser 50ft long 24in dia. 3ft deep Asset# NA

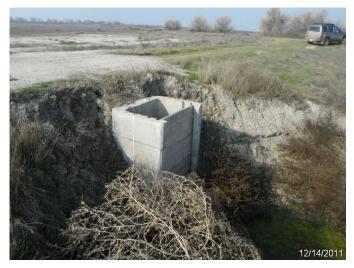
Photo: PIXL_C4_0532 Route: 407-001-0.54 Plastic WCS Flashboard Riser 40ft long 24in dia. 3ft deep Asset# NA

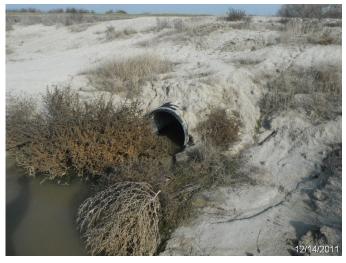
Photo: PIXL_C4_0533 Route: 407-001-0.54 Plastic WCS Flashboard Riser 40ft long 24in dia. 3ft deep Asset# NA

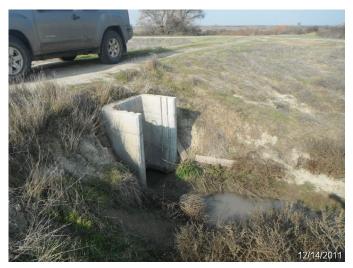
Photo: PIXL_C4_0534 Route: 408-001-0.56 Plastic WCS Flashboard Riser 30ft long 24in dia. 4ft deep Asset# NA

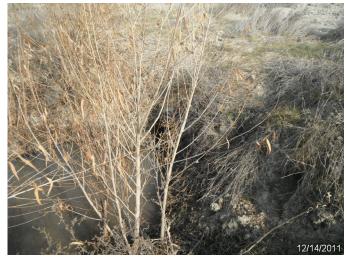
Photo: PIXL_C4_0535 Route: 408-001-0.56 Plastic WCS Flashboard Riser 30ft long 24in dia. 4ft deep Asset# NA

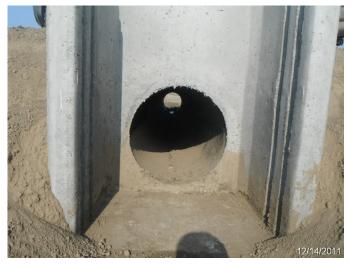
Photo: PIXL_C4_0538 Route: 409-001-0.15 Plastic WCS Flashboard Riser 30ft long 24in dia. 2ft deep Asset# NA

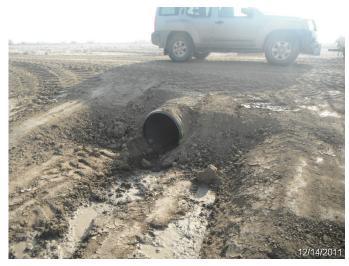
Photo: PIXL_C4_0539 Route: 409-001-0.15 Plastic WCS Flashboard Riser 30ft long 24in dia. 2ft deep Asset# NA

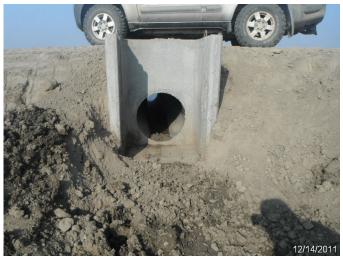
Photo: PIXL_C4_0540 Route: 409-001-0.43 Plastic WCS Flashboard Riser 30ft long 24in dia. 2ft deep Asset# NA

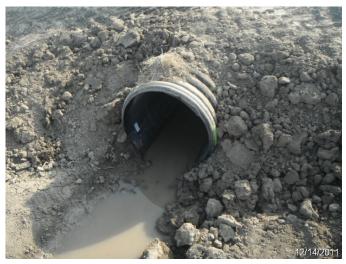
Photo: PIXL_C4_0541 Route: 409-001-0.43 Plastic WCS Flashboard Riser 30ft long 24in dia. 2ft deep Asset# NA

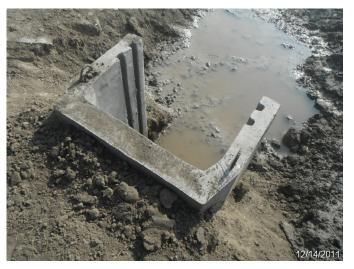
Photo: PIXL_C4_0542 Route: 409-001-0.62 Plastic WCS Flashboard Riser 30ft long 24in dia. 2ft deep Asset# NA 8-014

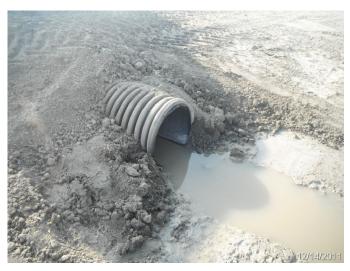
Photo: PIXL_C4_0543 Route: 409-001-0.62
Plastic WCS Flashboard Riser 30ft long 24in dia. 2ft deep Asset# NA
